Construction Presentation - Portfolio

About PDLA

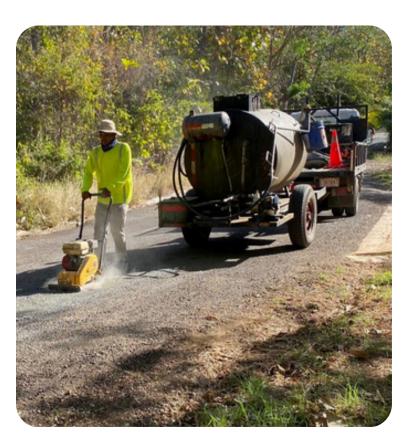
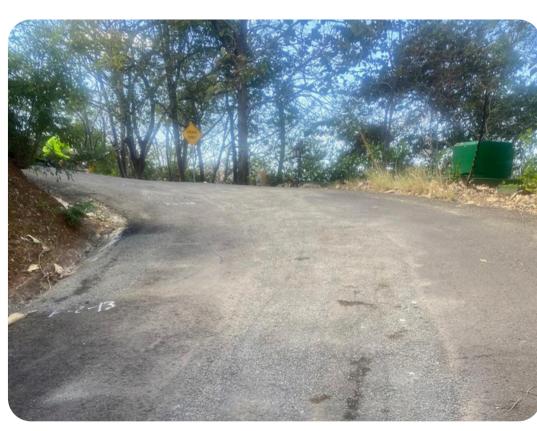
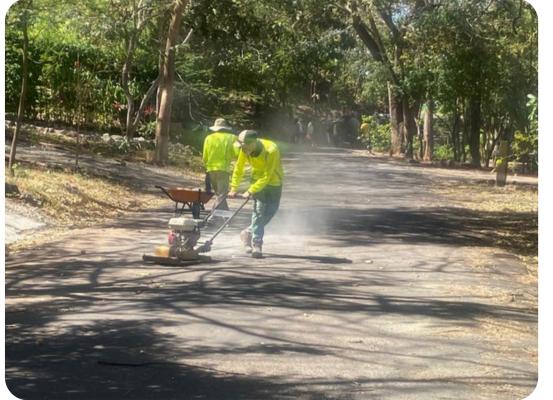
RANCHO VILLAREAL RESIDENTIAL CONDOMINIUM

Pothole repair and asphalt surface maintenance were carried out at the Rancho Villareal Horizontal Residential Condominium, located in a high-traffic residential and tourist area in the district of Tamarindo, Guanacaste.

• Cleaning and preparation of the affected surfaces • Application of 12mm hot mix asphalt (HMA) • Surface treatment using TS-1 type asphalt emulsion to ensure proper adhesion and durability

The internal roadways of the condominium were significantly improved, providing a safer, more uniform, and longer-lasting surface for residents and visitors alike.

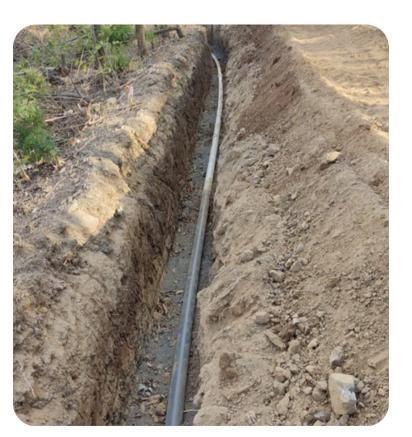
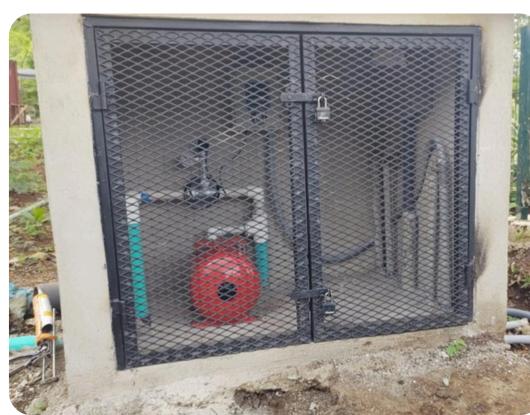
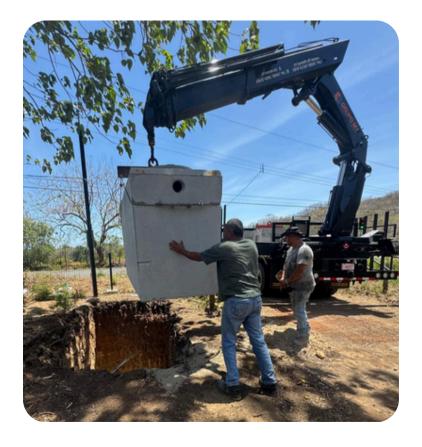
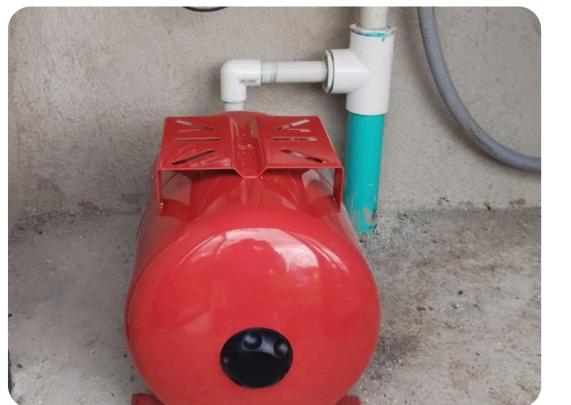
MATAPALO AQUEDUCT PROJECT

- and accessories
- Construction of pump house and utility easement crossings

Construction of essential infrastructure for a potable water supply system. The project was executed in accordance with technical and logistical requirements to ensure a functional and durable water distribution system.

- Excavation and installation of potable water
 - pipelines, valves, and connections
- Setup of a 2,500-liter storage tank, pump system,

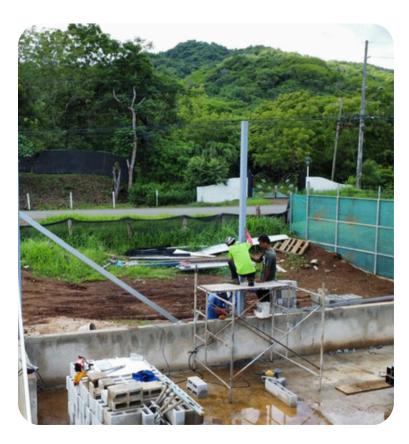
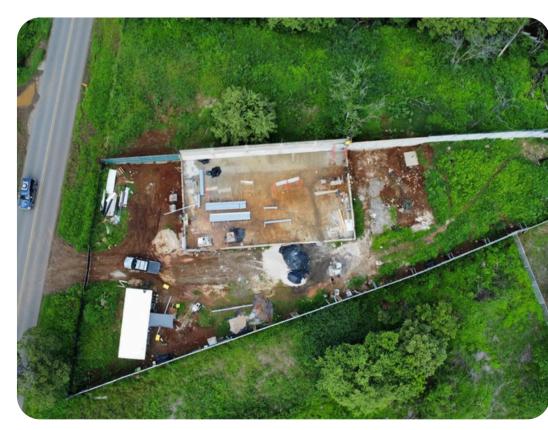
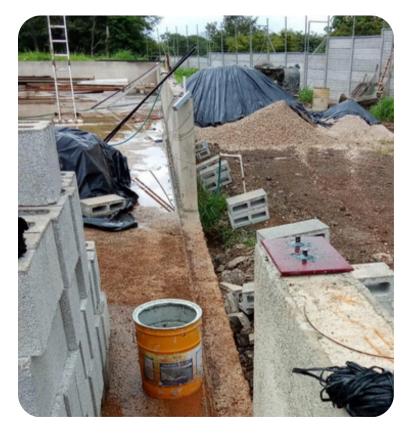
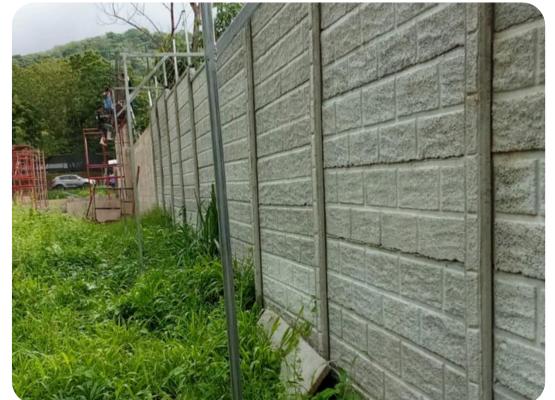
STORAGE WAREHOUSE CONSTRUCTION – GARITA, TAMARINDO

Construction of a primary 350 m² storage warehouse, a 60 m² annex, perimeter wall, and supporting works, on property registered under cadastral plan #5-4418-2024 in Garita, Tamarindo.

- Interior and systems: Restroom construction,
- plumbing, septic system, electrical installation, and finishes

- Structural work: Excavation, foundation backfill, reinforced concrete slabs, footings, and perimeter walls
- Building envelope: Steel structure, wall and roof cladding, ventilation mesh, and metal gates

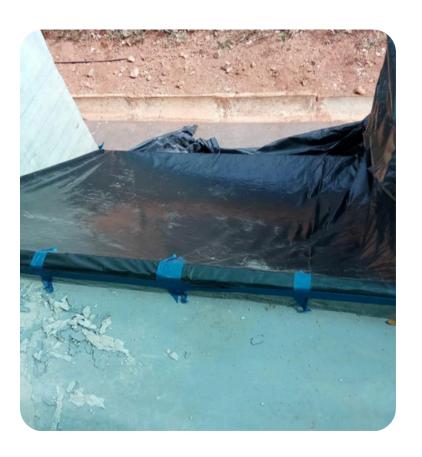
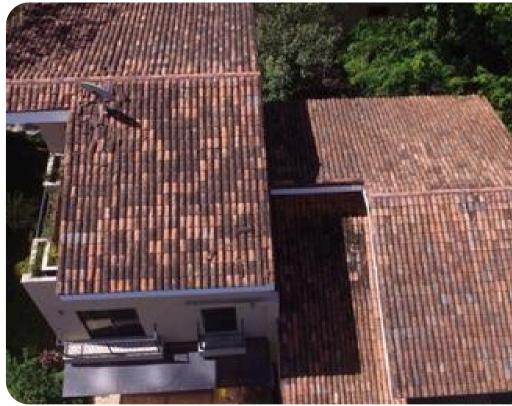
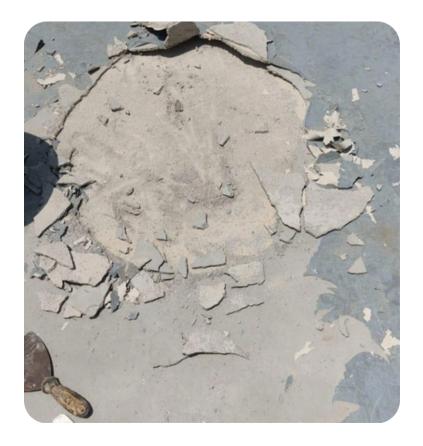
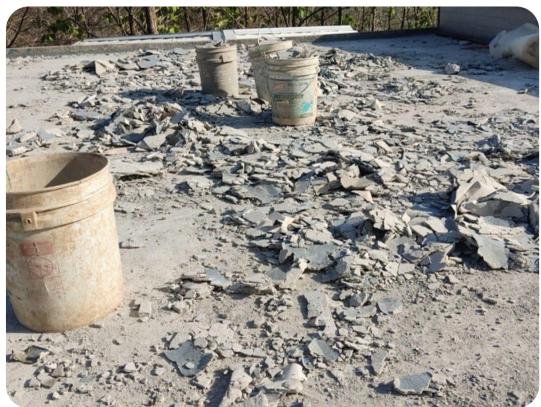
ROOF REPAIR – HOUSE #79, RANCHO VILLAREAL

Repair of roof slabs due to cracks and water leaks at House #79 in the Rancho Villareal Residential Condominium. The work was focused on restoring waterproofing and structural slope for effective water

• Surface preparation: Cleaning and pressurewashing of slabs, beams, and exterior walls • Waterproofing system: Slope correction with SIKAQUICK 1000 and liquid membrane application (SIKALASTIK 612) • Finishing touches: Installation of wall caps and exterior waterproof coating (SIKAGUARD 71 W)

The roof structure was restored with durable waterproofing solutions, improving long-term protection and eliminating infiltration issues in a highhumidity coastal climate.
